Corteco original quality
DECOUPLED PULLEY

THE BELT DRIVE MOVES A NUMBER OF THINGS

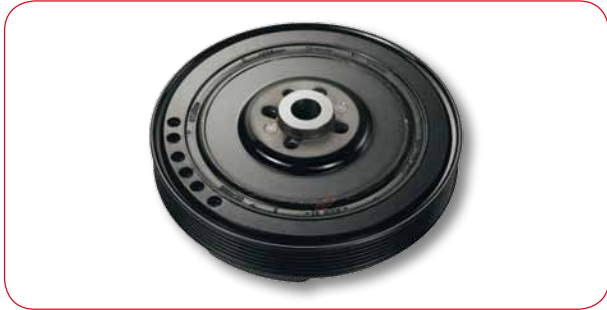
Transmission of crankshaft vibrations to ancillary units can produce an increased noise level, severe wear of adjoining components and undesirable vehicle vibration. The decoupled belt pulley is specially designed to meet the requirements of modern, high performance diesel engines, which develop a considerably higher vibration response than petrol engines.

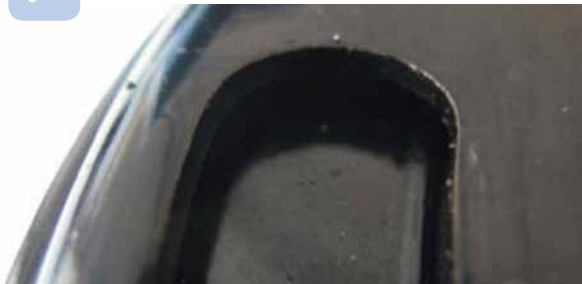
Original: after 100,000 km in the vehicle

No matter whether a drive belt is too loud or ancillary units are damaged by vibration – belt drive decoupling deficiencies are always associated with dissatisfaction. Anyone not using original parts for a decoupled belt pulley is making a false saving. Cheap counterfeit products generally lead to complaints after a short running time and loss of customer confidence. On the other hand, original parts from CORTECO still work reliably, often after 100,000 kilometers.

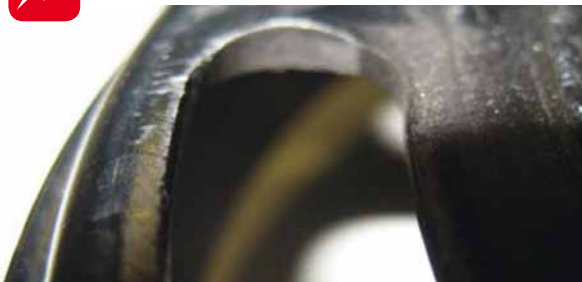
Copy: complaint after short running time
